BUILDING SCIENCE SERIES 40

Engineering Aspects of the 1971 San Fernando Earthquake

This report presents the observations of the NBS on-site inspection team (most photographs in this report were taken by the team). The material presented herein is intended to serve as (1) a documentation of damage resulting from the earthquake and (2) as a source document for further studies, research, and recommendations. This is particularly important as necessary remedial work and restoration have resulted in the removal of evidence that is essential for studies and evaluations.

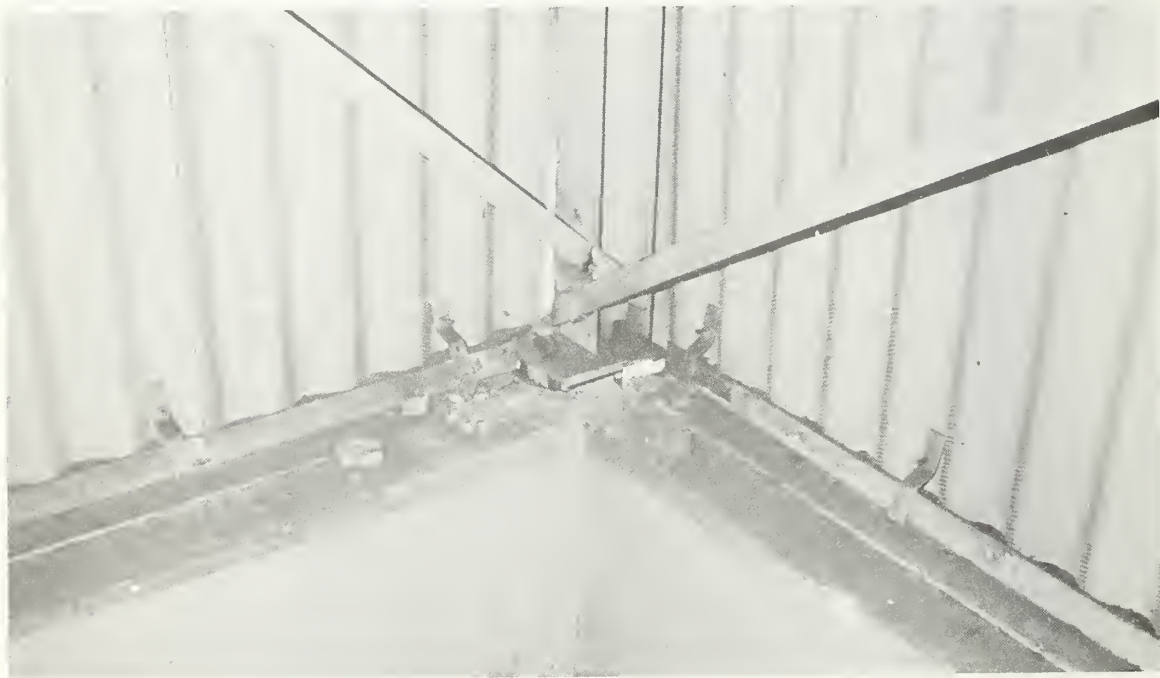
Figure 6.25 Corner of mechanical penthouse under steel column (interior view), Patrick Henry Jr. High School.

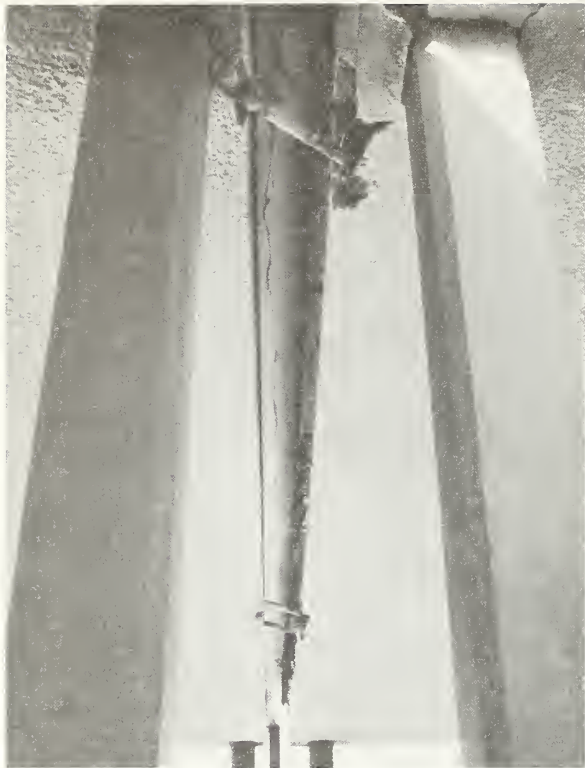
Figure 6.26 Electrical conduits were damaged at structural separation joints, Patrick Henry Jr. High School.

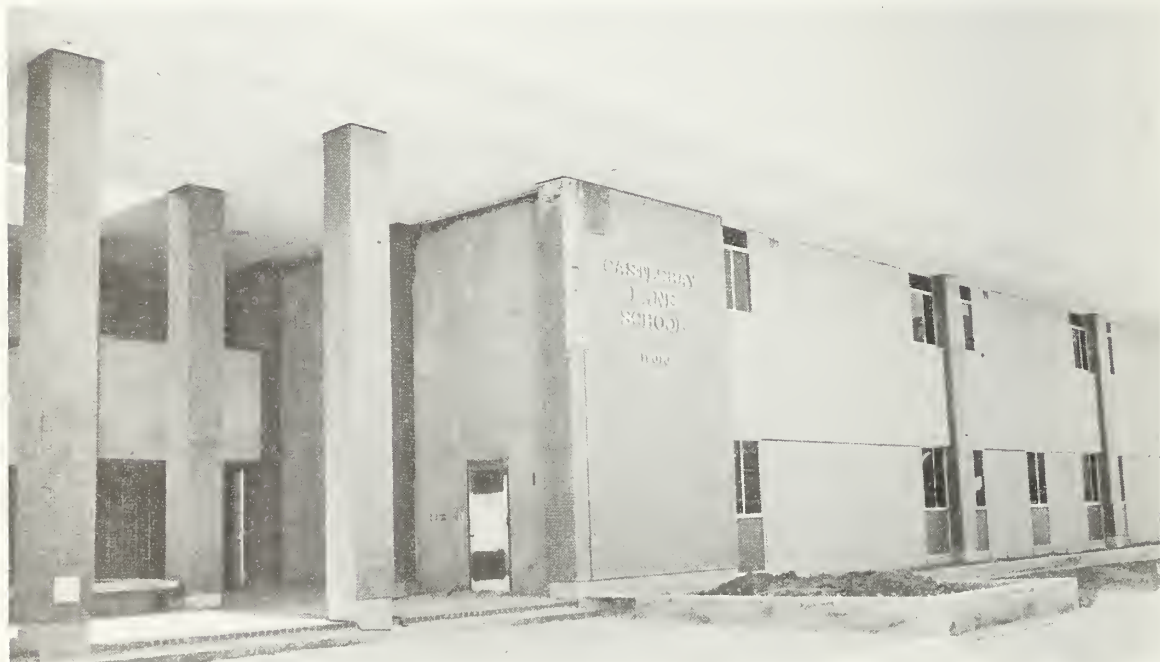
There was no structural damage caused by either the earthquake of February 9, 1971, or the aftershock of March 31, 1971. However, at the time of the main shock some ceramic tile veneer fell from the wall (fig. 6.27). The interior plaster cracked at many locations, the "T"-bar ceiling was damaged, the structural separation joint covers distorted, and mechanical equipment located on the roof moved off the isolation mounts (fig. 6.28). Repairs were underway when the aftershock of March 31, 1971, occurred causing additional ceramic veneer to fall from the wall, damage to corridor "T"-bar ceilings which had already been repaired (fig. 6.29) and extensive cracking of interior plaster at the joints of the gypsum board lath (fig. 6.30).

Figure 6.27 Ceramic tile fell from wall, Castlebay Lane School.

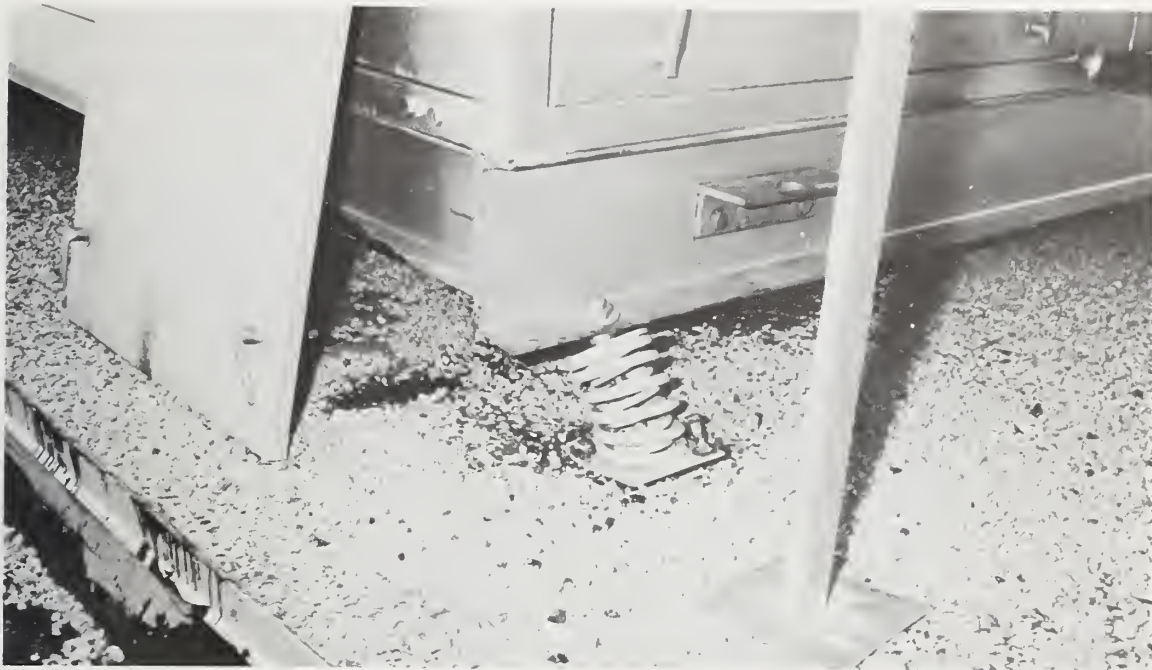
Figure 6.28 Mechanical equipment moved off the isolation mounts, Castlebay Lane School.

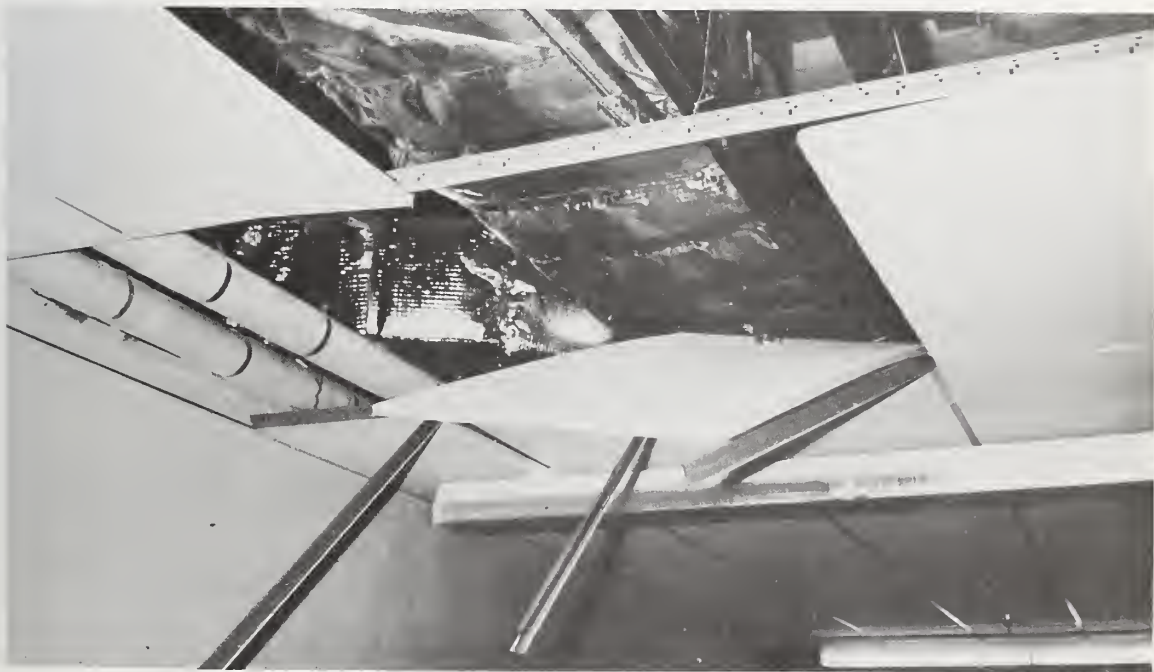
Figure 6.29 "T" bar ceilings were damaged, Castlebay Lane School.

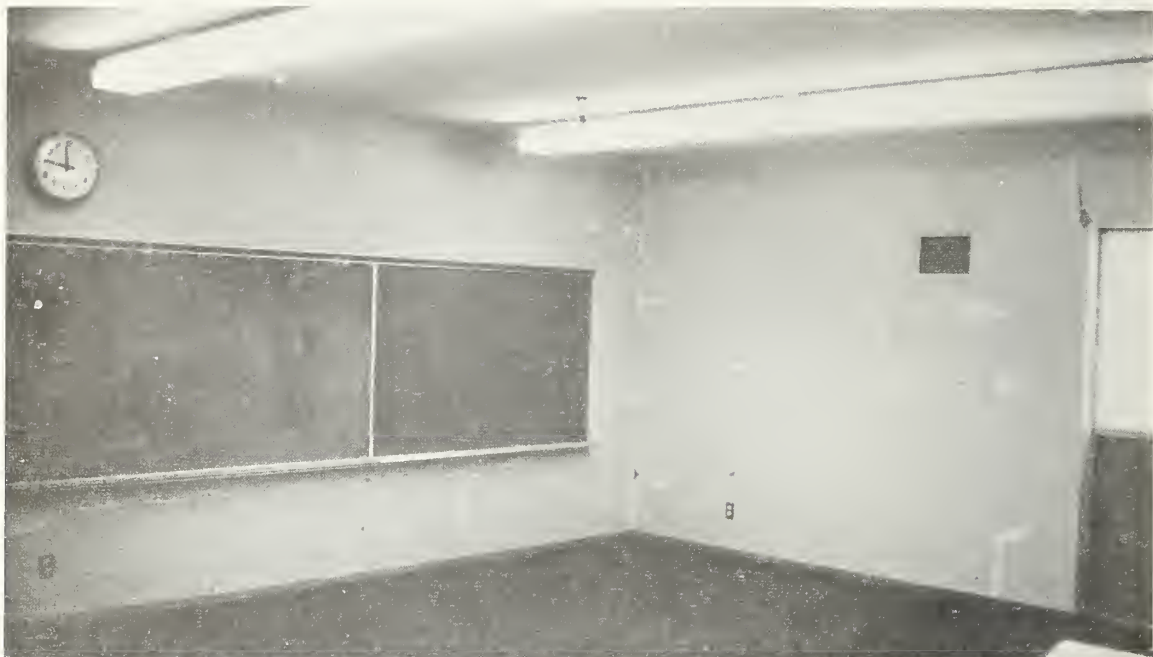
Figure 6.30 Plaster cracks at joints of gypsum board lath, Castlebay Lane School.

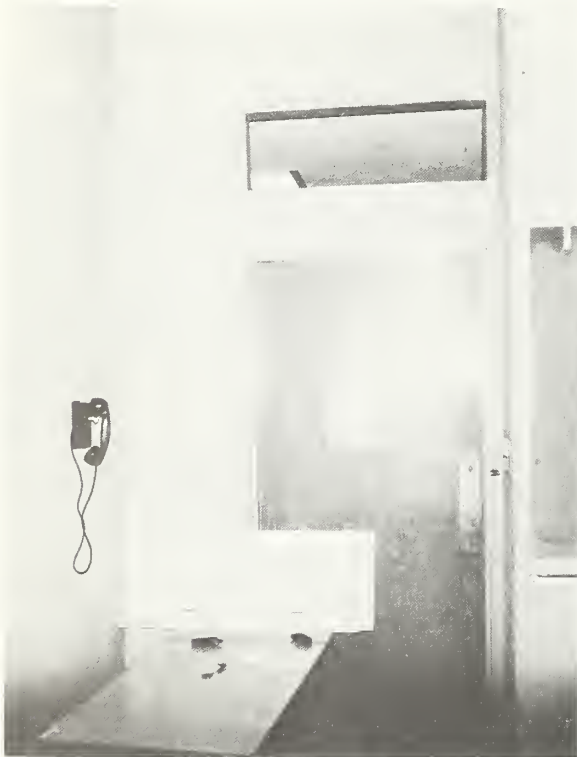
There are also transverse cracks near the middle and near the south end of the classroom portion. There was considerable light fixture damage; in addition, many ventilating louvers weighing about 40 pounds pulled loose from the corridor wall above the exit doors and fell to the floor (fig. 6.33). There was only minimal damage reported on the rest of the school site. However, the glass in the enclosure surrounding the exit stairwell of the gymnasium shattered and fell into the stairwell and could have been a serious hazard. The entire school is in use.

Figure 6.33 Ventilating louvers pulled loose from corridor wall above classroom doors (louver placed on table for photo), Crescenta Valley High School.

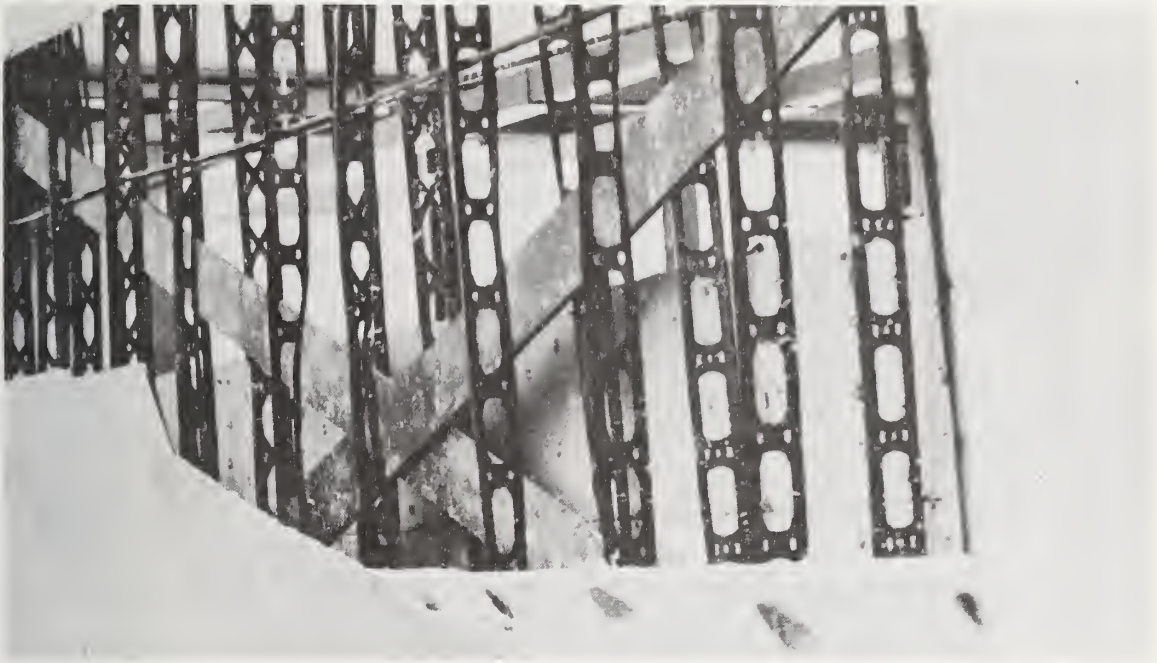
Figure 6.34 Flat steel bar braces concealed in transverse partitions, Clark Junior High School. Damage to partition caused by buckling of brace and striking the studs.

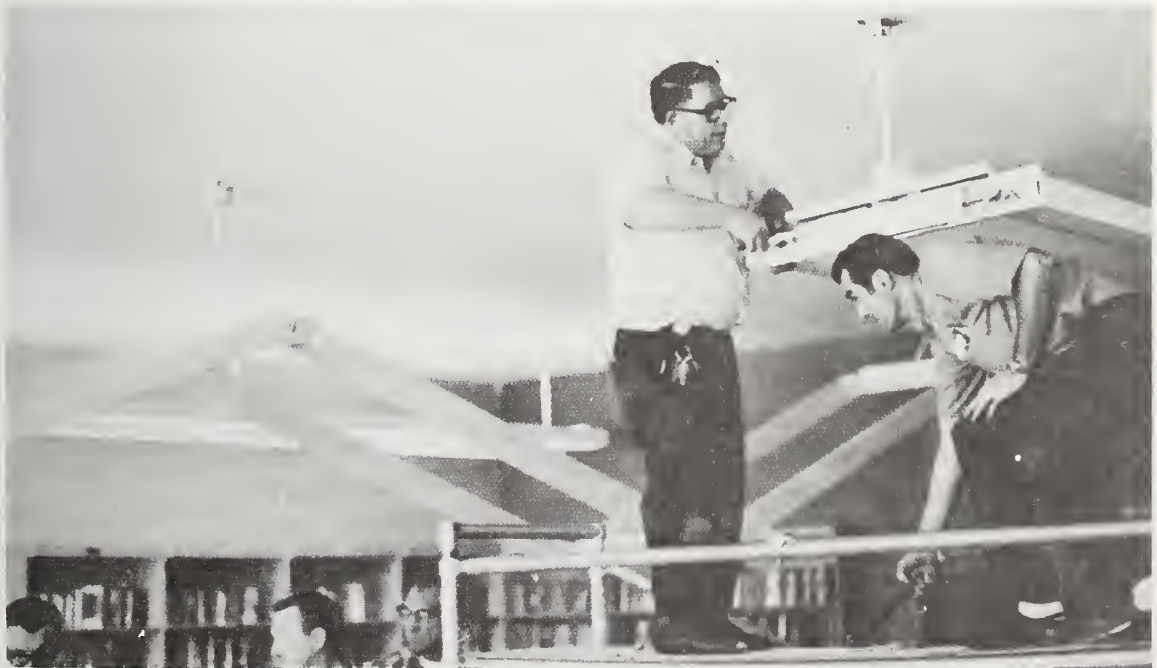
Figure 6.35 Damage to lighting fixtures at Clark Junior High School.

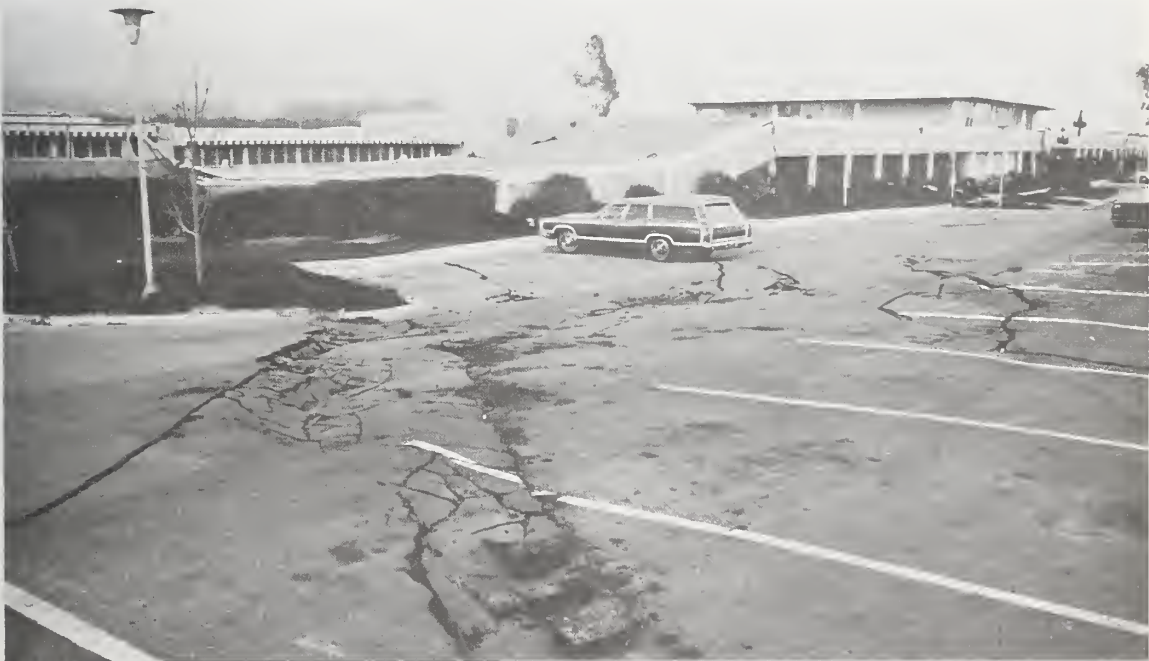
There was a collapse of a portion of the administration wing which occurred directly over the area of maximum ground fracture (fig. 6.37), and there was extensive damage without collapse at other areas of ground rupture (fig. 6.38 and 6.39). In the area adjacent to the actual ground cracking, the degree of damage was variable.

Figure 6.37 A portion of the Administration Wing collapsed at the Los Angeles County Juvenile Facility. Note the distortion of the ground surface.

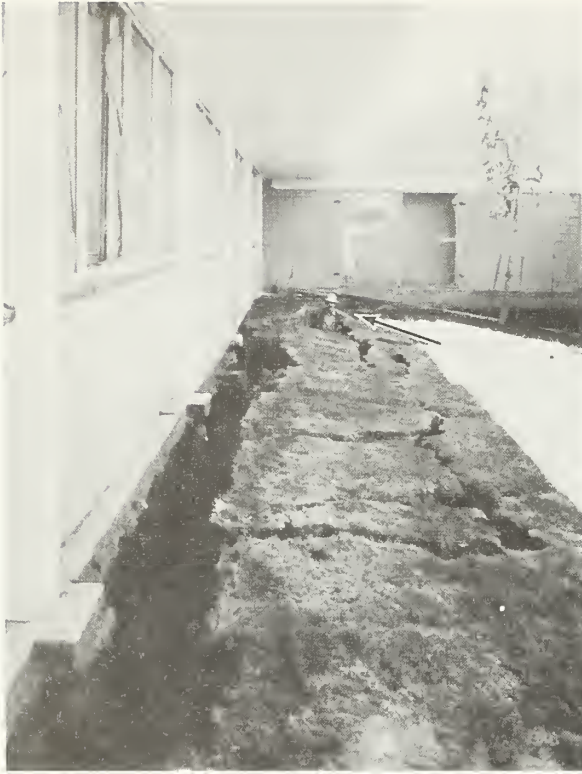
Figure 6.38 Ground crack adjacent to girls' living unit, Los Angeles County Juvenile Facility. Man standing in the crack is 6 ft 0 in tall.

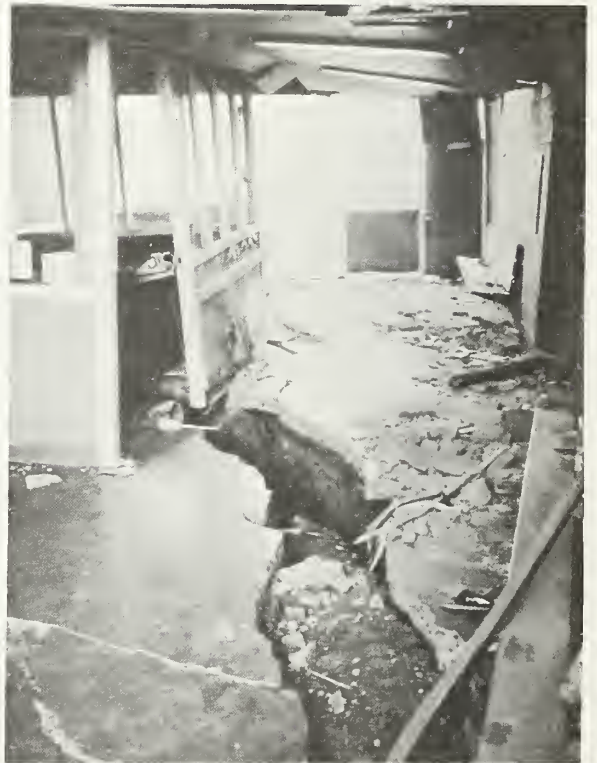
Figure 6.39 Large displacement in floor of girls' living unit, Los Angeles County Juvenile Facility. Structure did not collapse.

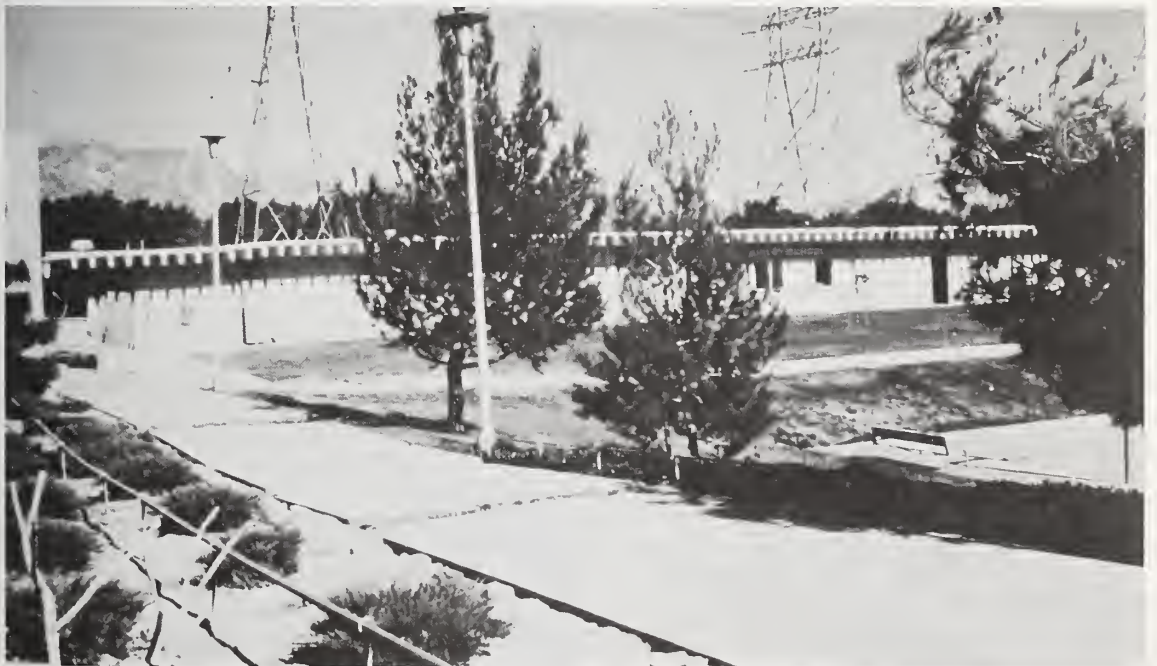
Figure 6.41 West wall of girls' school, Los Angeles County Juvenile Facility. Note displacement at left (north) end of building and severe ground rupture (see figure 6.48).

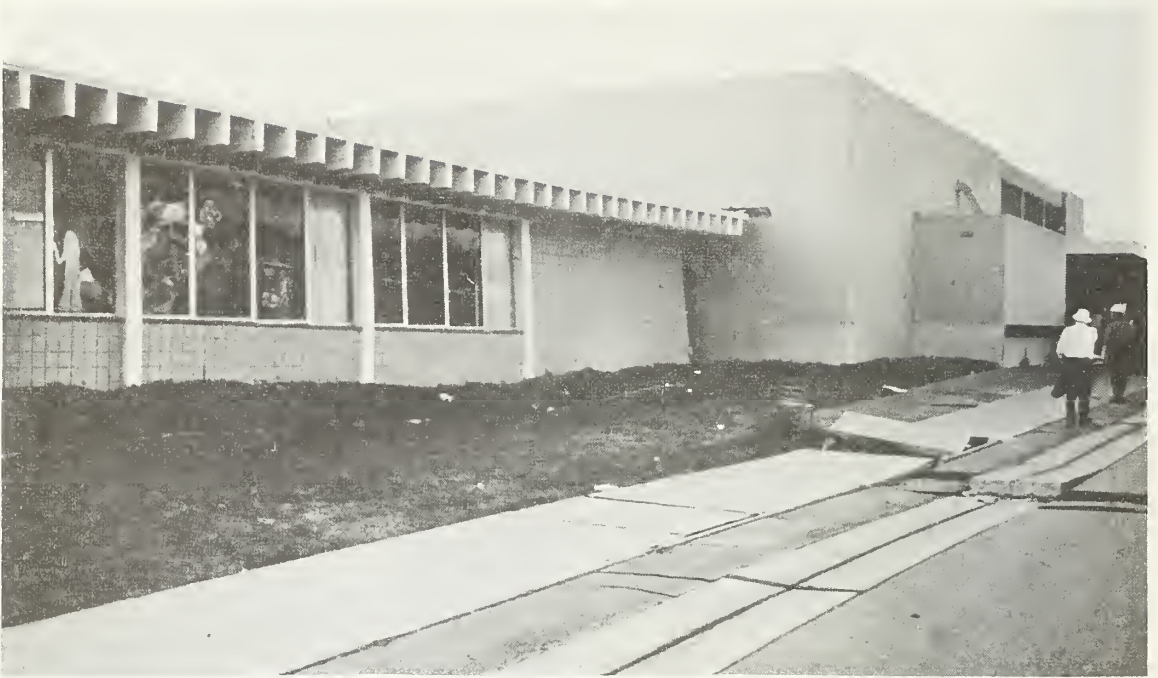
Figure 6.42 East wall of girls' school, Los Angeles County Juvenile Facility. Note distress at right (north) end adjacent to taller (cafeteria) building and ground rupture.

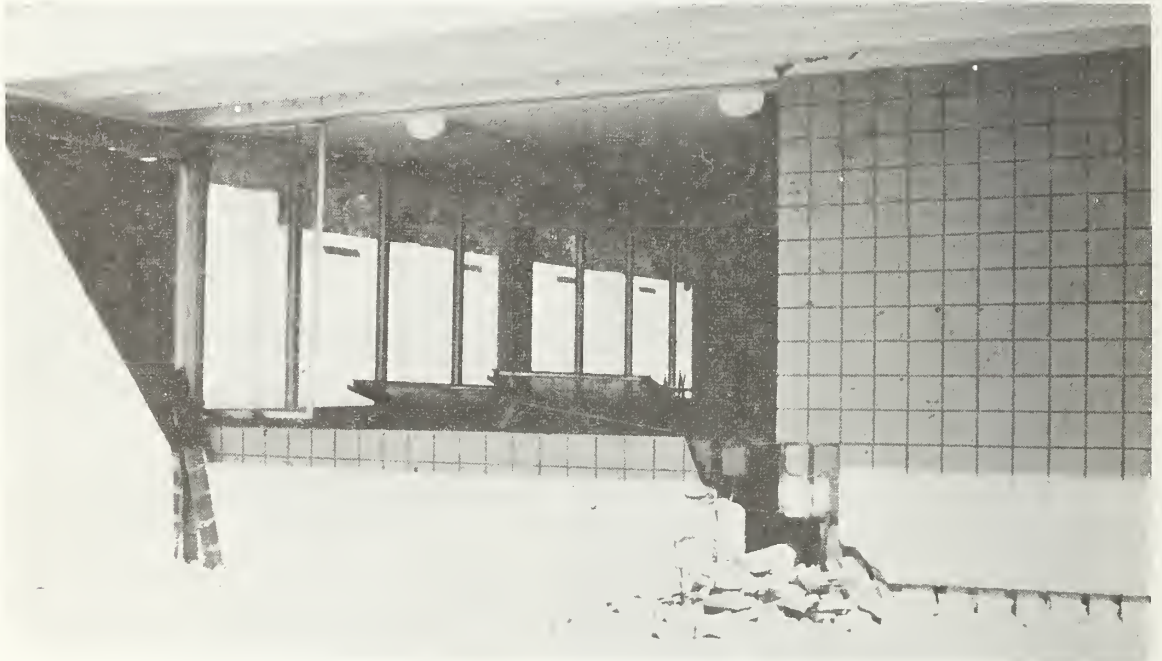
The school buildings at this institution survived the quake very well (fig. 6.40, 6.41 and 6.42). The west end wall of the boys' school was severely damaged and one window fell inwardly (fig. 6.43). Some of the perimeter ceiling in the west classroom was damaged; however, the contents of the room remained intact and it appears that the classroom would have been safe (fig. 6.44). There was some minor displacement of concrete blocks at the tops of transverse partitions (fig. 6.45). The walls at the junction of the boys' school and the gymnasium were cracked (fig. 6.46). The glass in the east and west clerestory between the trusses in the gymnasium fell to the ground and the bracing rods between the roof and the top of the walls either stretched or broke

Figure 6.43 Damage to west wall of boys' school, Los Angeles County Juvenile Facility. Window fell inward.

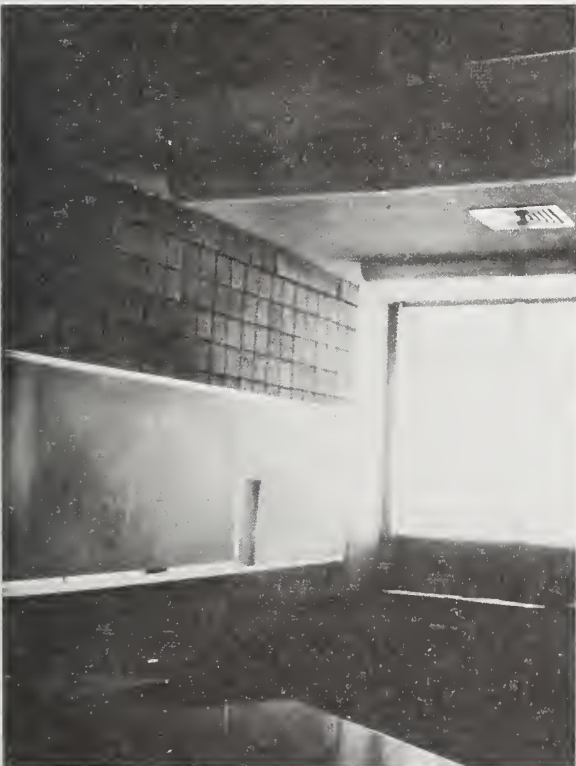
Figure 6.45 Displacement of concrete block at top of transverse partition, Los Angeles County Juvenile Facility.

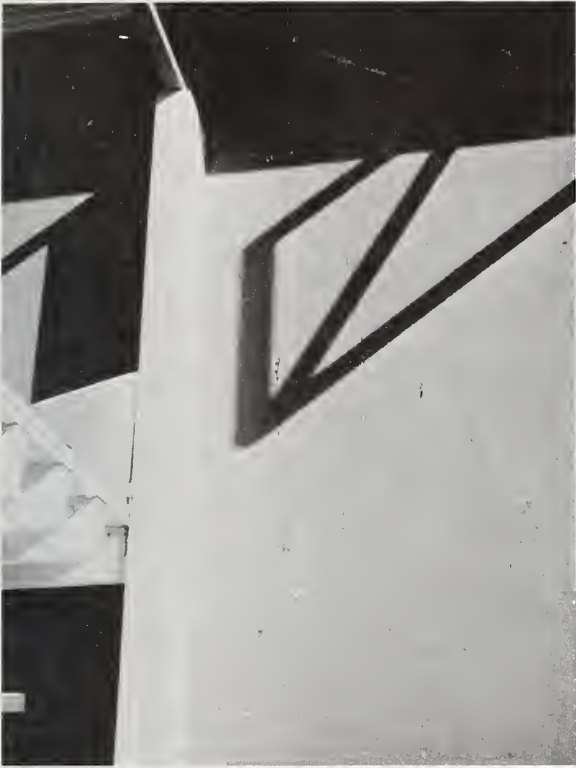
Figure 6.46 Cracked wall at junction of boys' school and gymnasium, Los Angeles County Juvenile Facility.

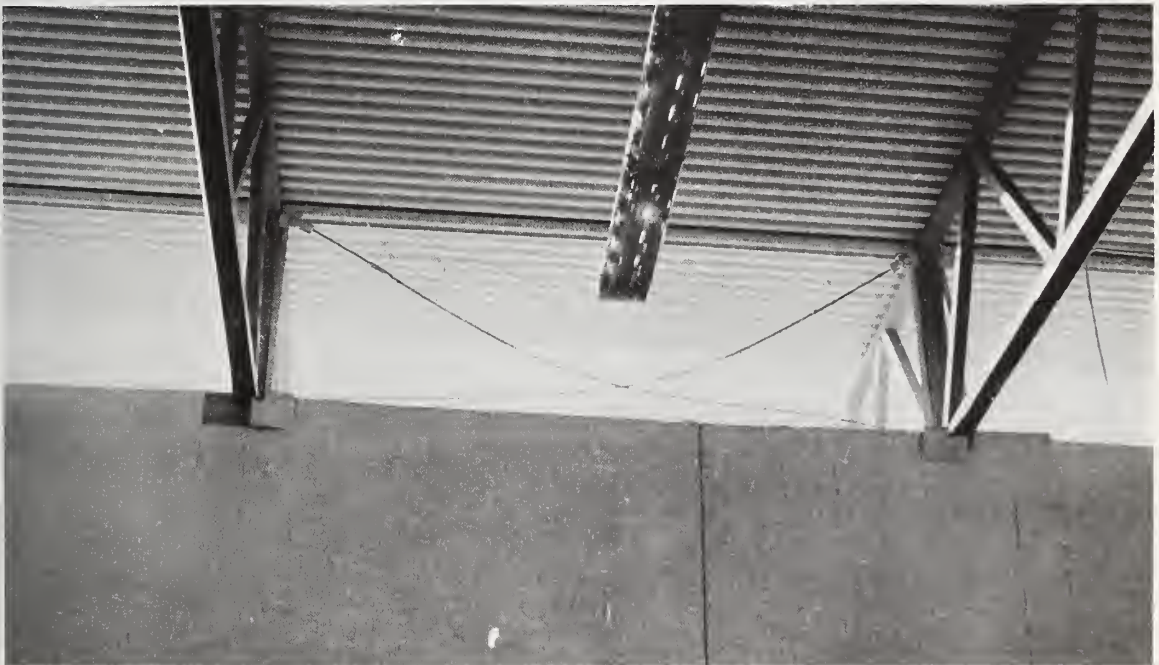
Figure 6.47 Clerestory windows of gymnasium fell out and bracing rods stretched, Los Angeles County Juvenile Facility.

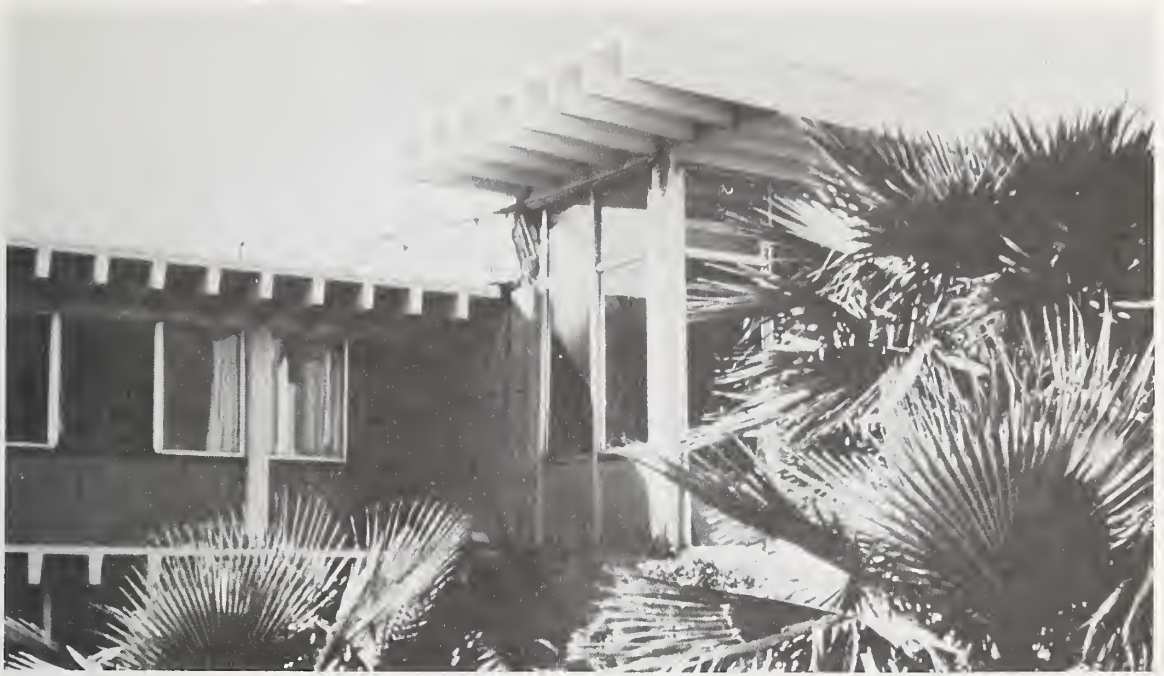
Major damage on other buildings consisted of shattering of walls at locations of change in roof elevations (fig. 6.49 and 6.50) and fracturing of concrete block walls constructed with "stacked bond", in which the horizontal reinforcing was concentrated only at the bond beam (fig. 6.51 and 6.52). The better behavior of the school buildings can be attributed to the more restrictive rules and regulations of the Field Act since the other factors (Architects, Engineers, Contractors and Inspectors) were the same for both types of buildings. The school buildings could be economically repaired; however, the entire facility has been vacated and may be abandoned.

Figure 6.49 Damage to wall at change in roof elevation (exterior), Los Angeles County Juvenile Facility.

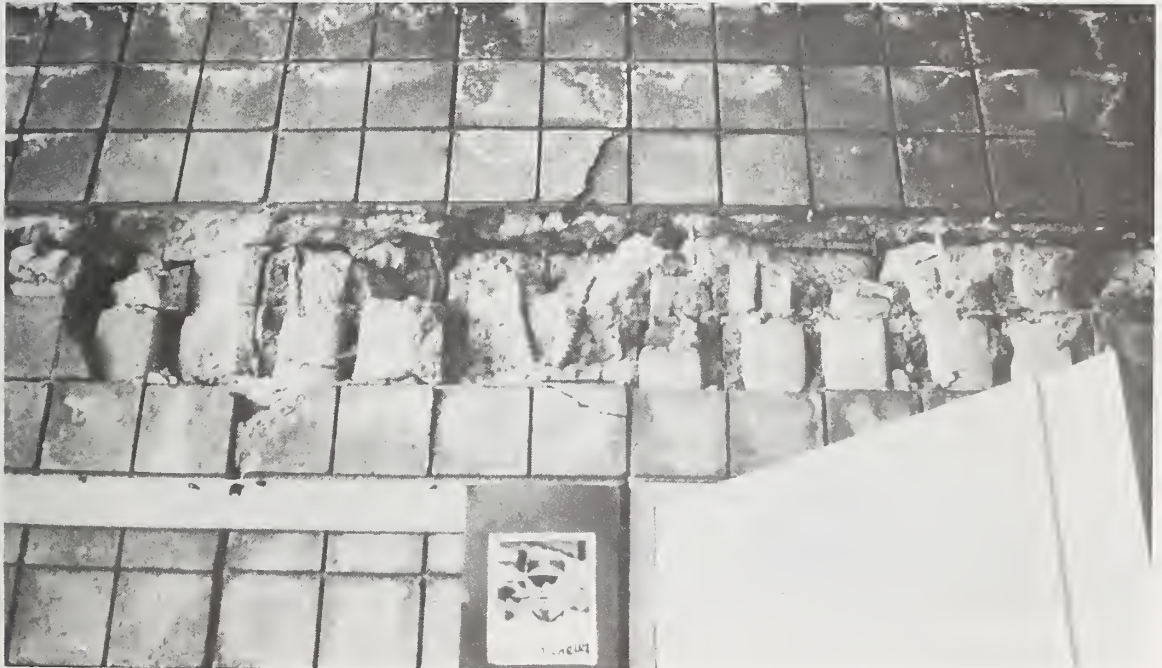
Figure 6.50 Damage to wall at change in roof elevation (interior), Los Angeles County Juvenile Facility.

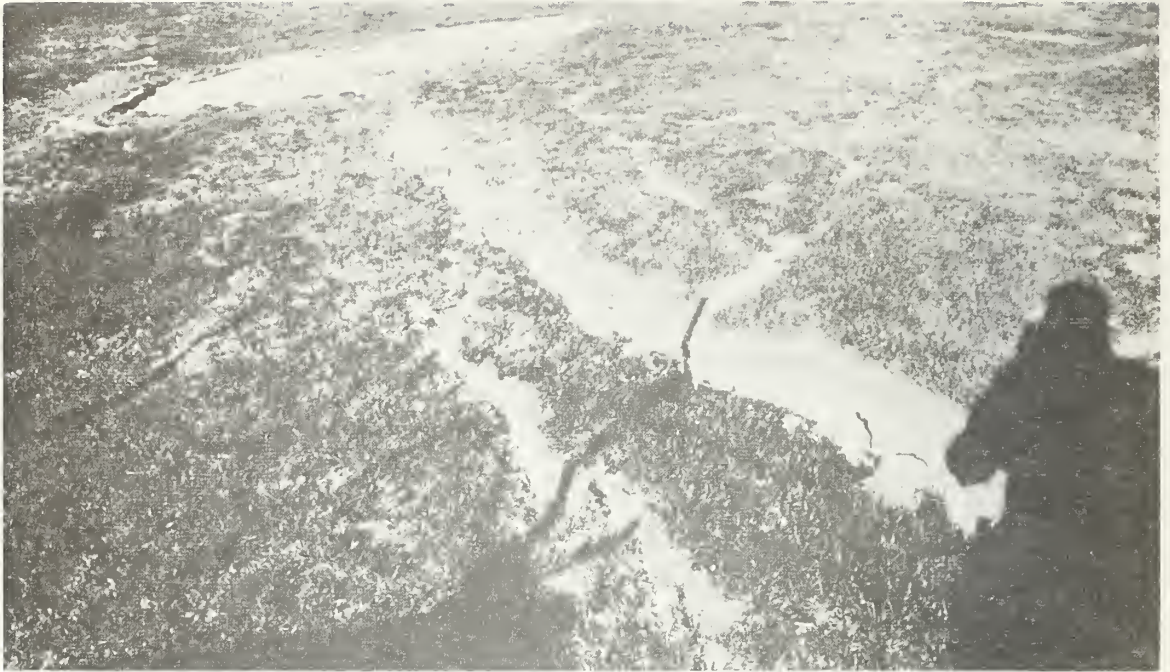
Figure 6.53 Eight-inch vertical displacement in out-door recreation area, Camp Karl Holton.

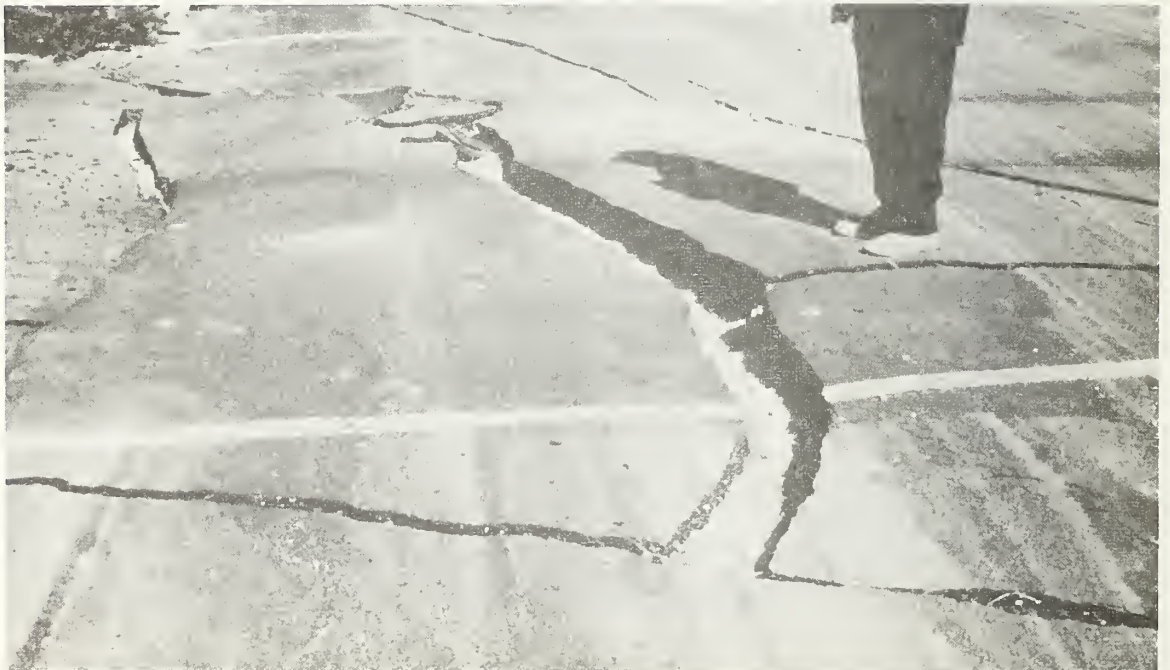
Figure 6.54 Extensive cracking of parking lot pavement, Camp Karl Holton.

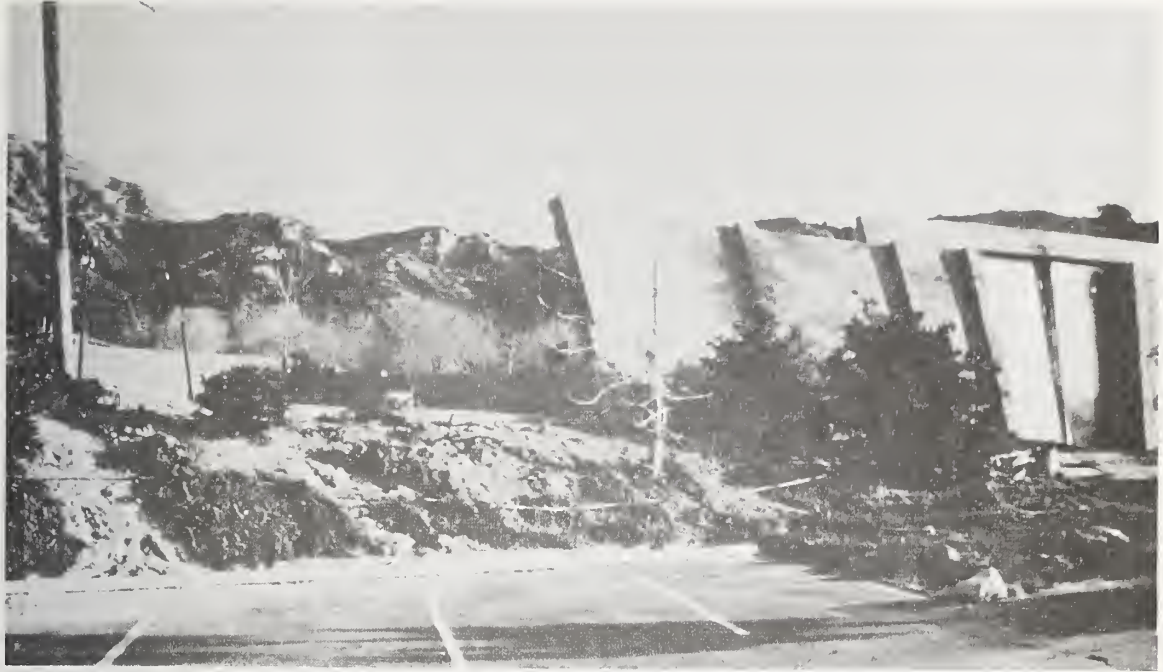
Figure 6.55 A portion of perimeter security wall has fallen; some is severely tilted, Camp Karl Holton.

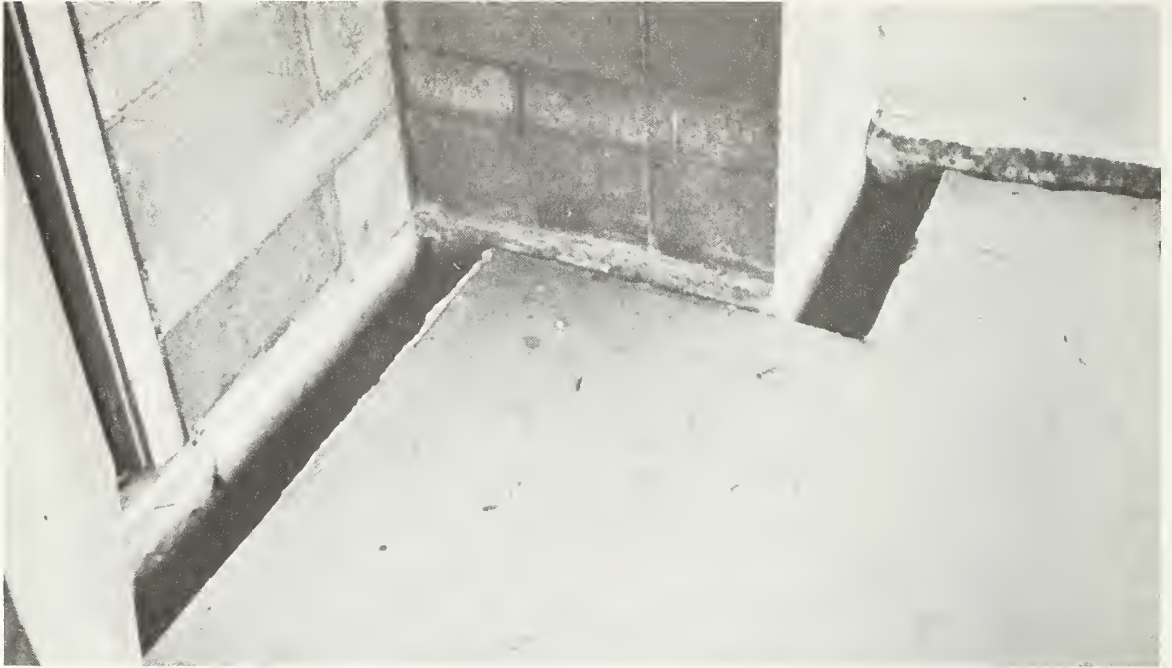
The recreation building suffered severe structural damage. The concrete block walls which were grouted only in the reinforced cells shattered and were displaced as much as four inches laterally at the base (fig. 6.56 and 6.57). The living unit was undergoing major alterations at the time of the earthquake. Thus, the damages sustained do not necessarily reflect the condition of the building. The vehicle storage building has a broken bottom chord at one gabled wooden roof truss, and the wood sheathing appears to be supporting the roof by plate action. Approximately six inches of vertical displacement between the masonry classroom building and the portable classroom building was noted (fig. 6.58). Either

Figure 6.57 Recreation Building at Camp Karl Holton. Four-inch displacement between slab and wall.

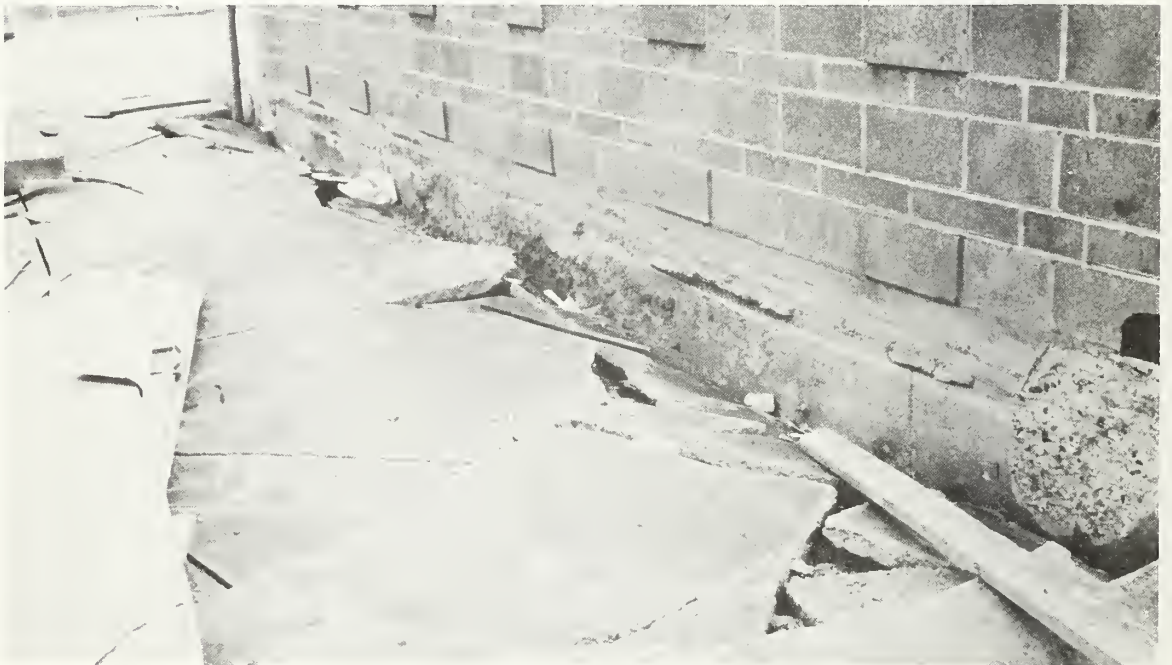
Figure 6.58 Approximately 6 inches of vertical displacement between masonry classroom building and the portable classroom building, Camp Karl Holton.

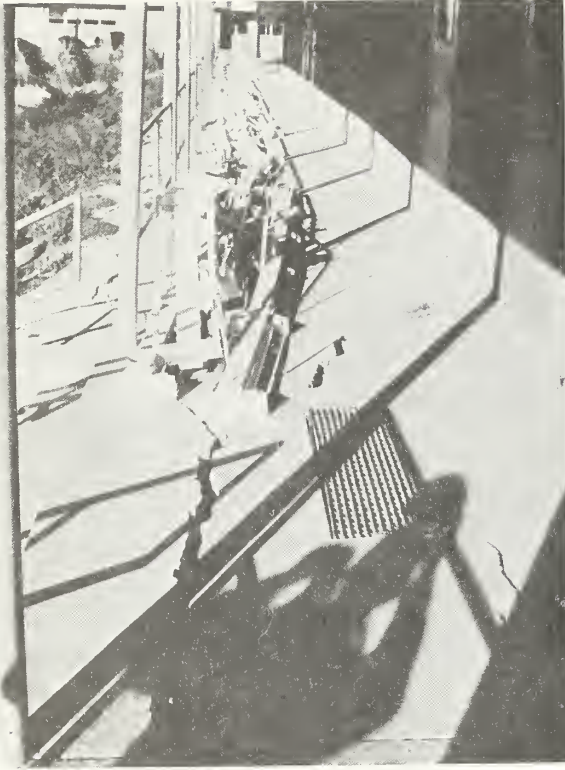
the portable building and the ground on which it is supported dropped or the adjacent area, together with the building thereon, was raised. The building remained intact although two covered arcade pipe columns were displaced a few inches at the base where the slab on grade pulled apart (fig. 6.59). The stem mounted lighting fixtures in all buildings were severely damaged and most fell to the floor (fig. 6.60). Damage to the portable classroom was minimal. A sheet metal foundation clip was distorted and an interior partition was offset a quarter of an inch at a joint in the wallboard. The classroom building could be used in its present condition if the light fixtures were reinstalled; however, the complex has been vacated pending a study of the disposition of the camp.

Figure 6.59 Arcade pipe columns were displaced at base where slab on grade pulled apart, Camp Karl Holton. (Damaged lighting fixtures were removed from buildings and stored on walkway.)

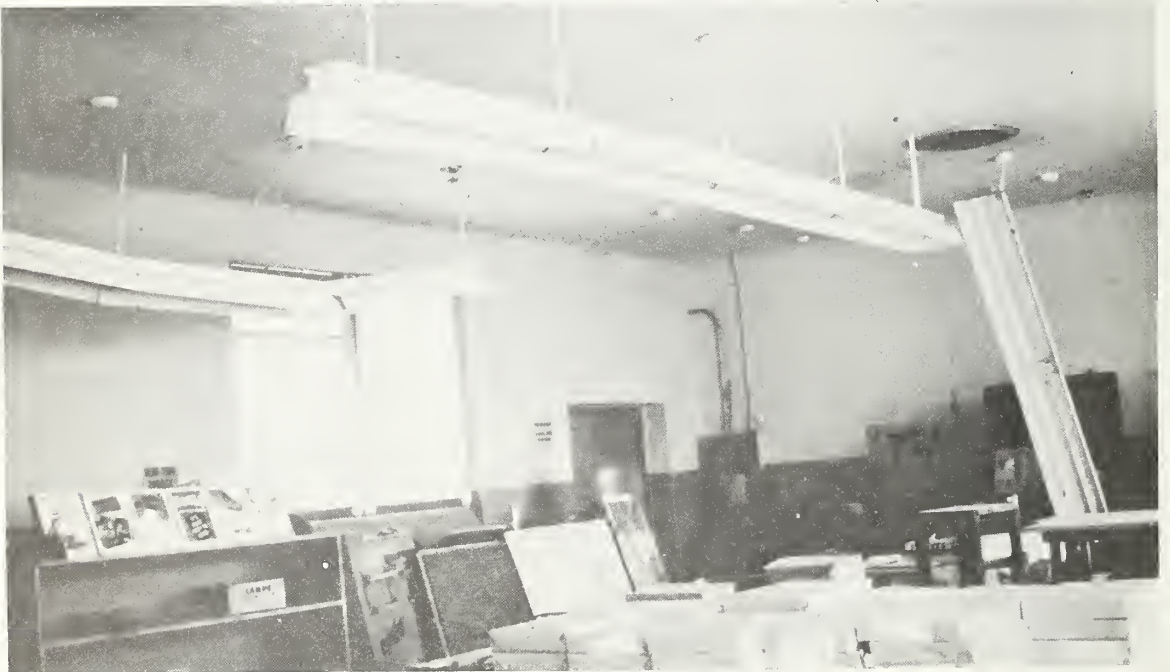
Figure 6.60 Stem mounted lighting fixtures were severely damaged, Camp Karl Holton.

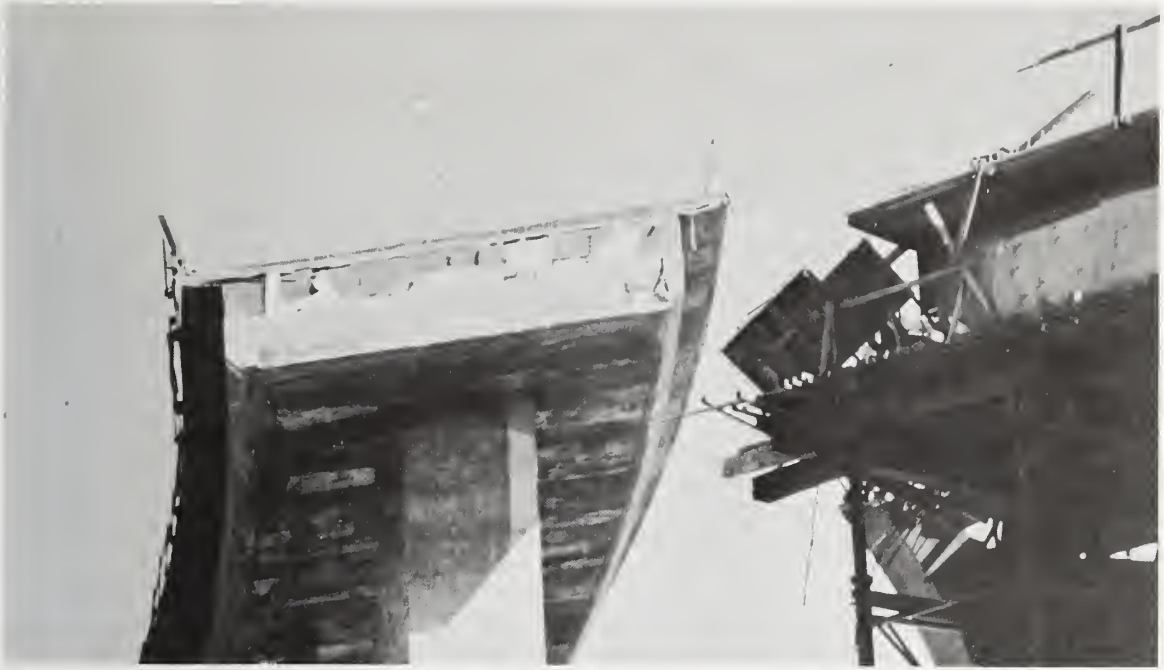
direction and 15 in the transverse direction. The slenderness of the column and the nature of the hinge seat can be seen in figure 7.5, which is a post-failure view of pier 5. Figure 7.6 shows the hinge cross section immediately adjacent to pier 3. Reference to the hinge detail as shown in figure 7.4 indicates that each web of the box girder rested on a 2-in thick by 10-in deep by 30-in wide elastomeric bearing pad and the center bay of the hinge seat had a 1-ft high raised shear key, which was approximately 5-ft 6-in wide. The raised cross section of this shear key is visible in figure 7.6. The only positive ties in the longitudinal direction were 1 1/2-in equalizing bolts, one of which was placed in the center of each of the three cells, parallel to the axis of the bridge.

Figure 7.6 Post-failure view of Pier 3 and hinge seat with shear key.

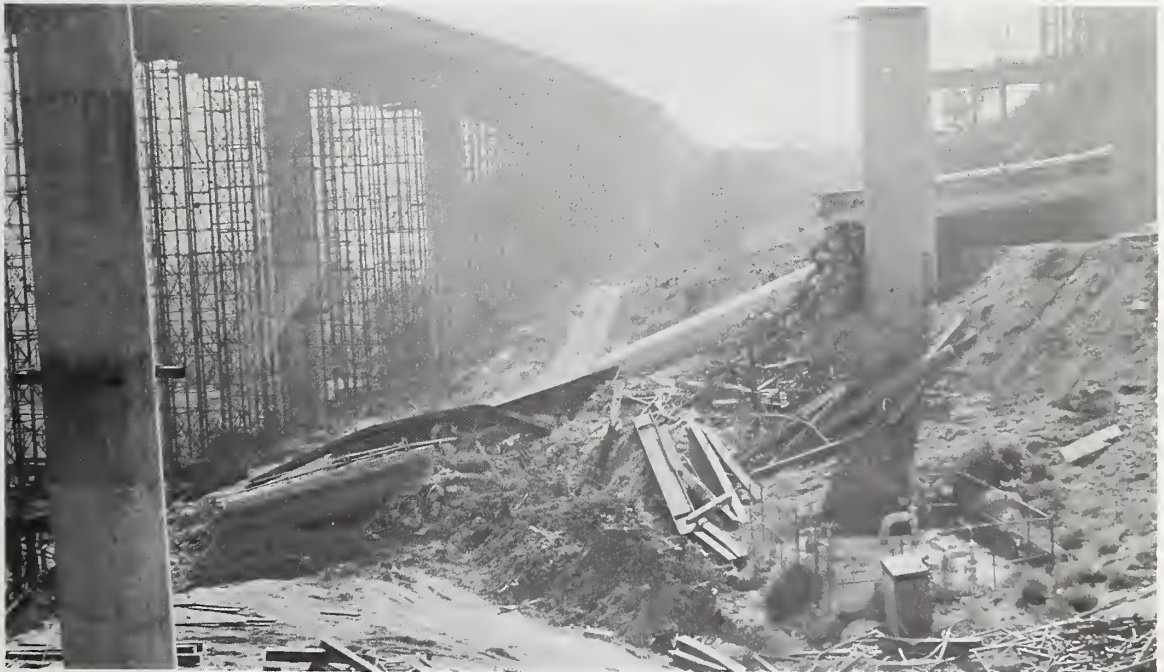
The box girder had stiffening diaphragms at the center lines of the span and a 9-ft 6-in wide solid diaphragm above the pier, with the column reinforcement extending up into this diaphragm to within 1 ft of the top deck surface. Figure 7.7 indicates the debris after the collapse. Sections of the box girder can be seen at the upper right of the picture (resting against the pier from the other undercross bridge). The column can be seen lying across the center of the picture, and additional sections of the box girder can be seen in the lower left. There were obvious marks along the upper edge of the column standing in the upper right of the picture, which indicated that the girder had brushed against it with substantial force while dropping. Additional failure detail can be seen in figure 7.8, which shows the column top as it would be seen from underneath the structure. It can be observed that the column stub and column bars have pulled out of the cast-in-place diaphragm. This can be seen with greater clarity in figure 7.9, which shows the top of the column in the center of the picture, resting on a wrecked hoisting crane. It is extremely interesting to note that none of the heavy No. 18 cross bars, which were used as the main top reinforcement in the wide diaphragm, appear in the picture. These bars were reported to be in the rubble at the base of the column.

Figure 7.7 Debris from the South Connector Overcrossing.
